### **Groundwater Dependent Ecosystem (GDE) Management and Monitoring Plan**

#### **Isaac Downs Project**

Prepared for **Stanmore IP South** by

**Final – April 2021** **(Revised following DAWE review).**

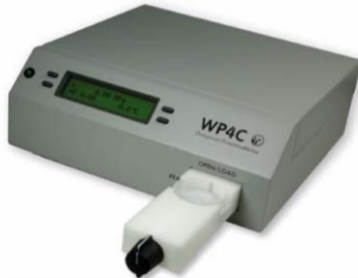
**B3.** The WP4C Dew Point PotentiaMeter available for hire from ICT International Pty Ltd.

1. A 7ml soil sample is inserted into the sample draw of the potentiaMeter in a 15ml stainless steel sample cup.
2. A soil sample takes between 10 -15mins to analyse.
3. Faster settings (fast mode) should be used for samples with limited water holding capacity such as sand.

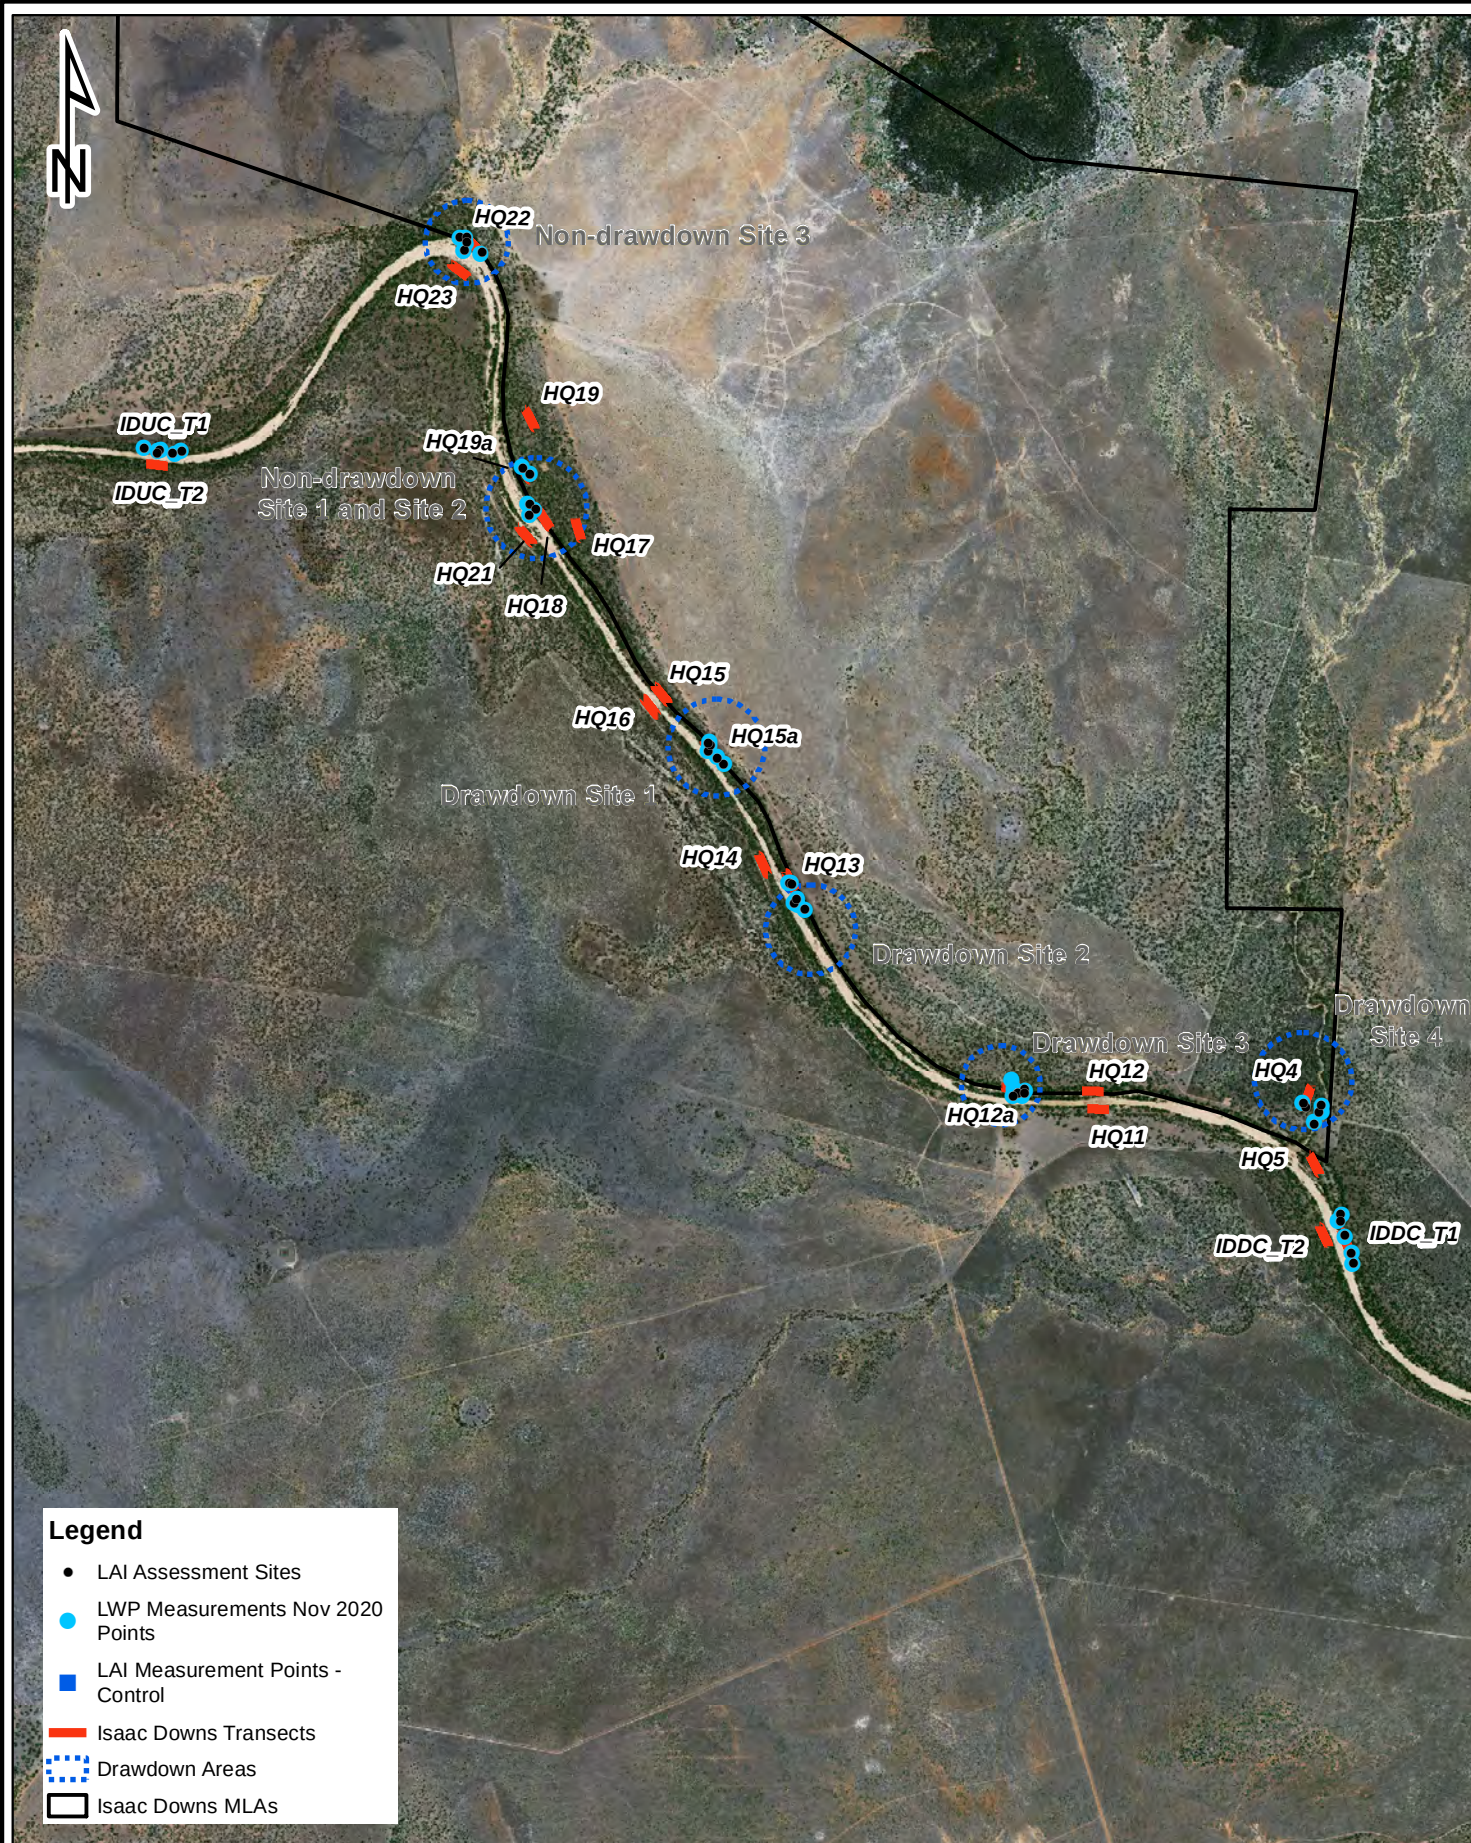
***Appendix E9. Natural colour imagery shown in relation to LAI and LWP monitoring points, NDVI transects at each GDE monitoring area.***

### Appendix E9. Worldview natural colour imagery in relation to GDE monitoring areas and points
